#### **Technical Service Report**

00293-CTS-00023-bem

## **Kebony Teak**

### Kebony Teak 00293-CTS-00023-bem

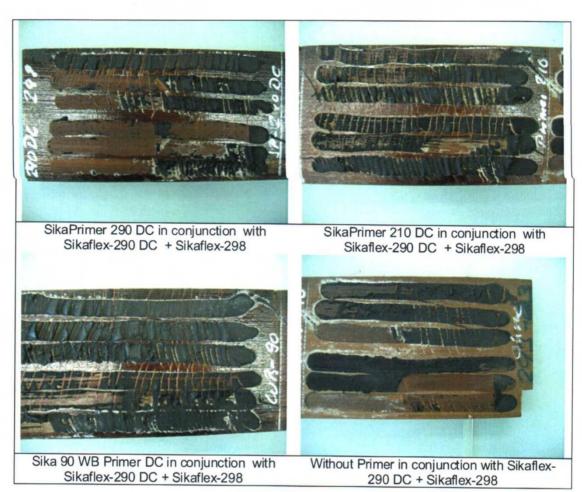
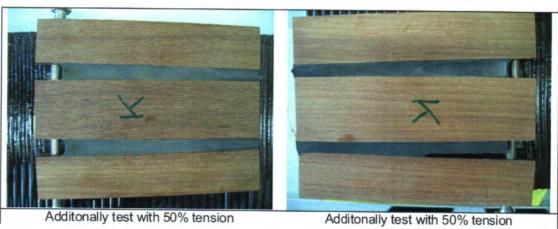
- Sikaflex-298 FC and Sikaflex-290 DC in conjunction with SikaPrimer-210
- Sikaflex-298 FC and Sikaflex-290 DC in conjunction with Sika-90 WB Primer
- SikaPrimer-290 DC showed adhesion loss from the substrate after cataplasma. Primer shows partly adhesion loss from the wood.

In addition to that, the wood has been broken in itself after cataplasma.

PreTreatment	Cleaner	+ [min]	t Primer .	f t	t Adhesive		Œ	Results		
						8	O	L	9	7
none	none	3	without		Sikaflex® -290 DC black	-	4	4		4
none	none	3	without		Sikaflex® -298 FC	٦	4	1		-
none	none	S	Sika® Primer-290 DC	30	Sikaflex® -290 DC black	-	PVU	PVU		PVU
none	none	S	Sika® Primer-290 DC	30	Sikaflex® -298 FC	-	PVU	1		-
none	none	S	SikaPrimek-210	30	30 Sikaflex® -290 DC black	-	1	1		1
none	none	S	SikaPrimer-210	30	Sikaflex® -298 FC	1	1	1		-
none	none	S	Sika WB 90	30	Sikaflex® -290 DC black	1	1	1		2
none	none	S	Sika WB 90	30	30 Sikaflex® -298 FC	-	1	1		-

Good adhesion over all exposures could be reached after following pretreatment:
